Senior Project – Corrosion Prevention

Project Title: Corrosion Prevention

Project Sponsor: Pete Schwartz, Cal Poly Physics

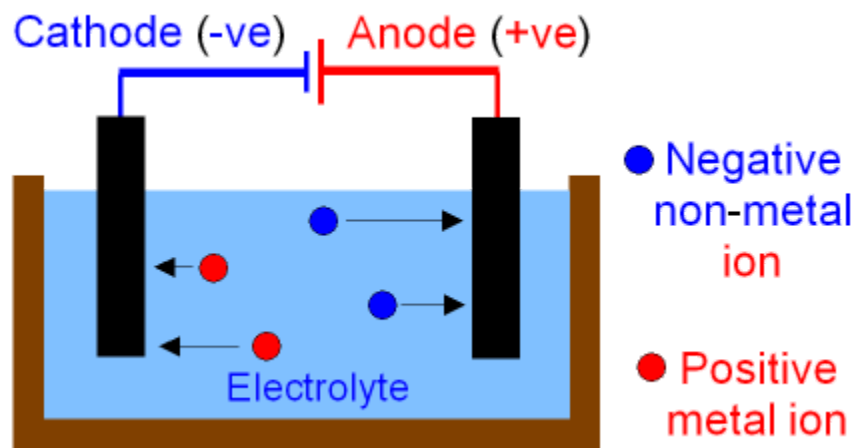
Electrolysis is considered a form of corrosion and occurs when two metals connected by a wire are placed in an electrolytic solution and a voltage is applied. These two metals need not be different metals. The voltage source forces a non-spontaneous reaction to occur. The anode is whichever metal is connected to the positive lead from the power source. The anode will shed ions and electrons and deposit those ions elsewhere. If copper were the anode, it would shed copper ions. Those ions would react with other ions present in the electrolyte to become more stable, and they would appear a green color. The green colored copper ions could deposit onto the same piece of metal they came from, or they could deposit elsewhere. See the diagram below. To prevent electrolysis, see steps below:

1. Remove the metals from the electrolytic solution by using a dielectric oil or coat the metals heavily with epoxy.
2. Remove or reduce the applied voltage.

As previously stated, no phase change materials are dielectric. Therefore, there is currently only one effective way for us to slow electrolysis in ISECs, which is by using epoxy.

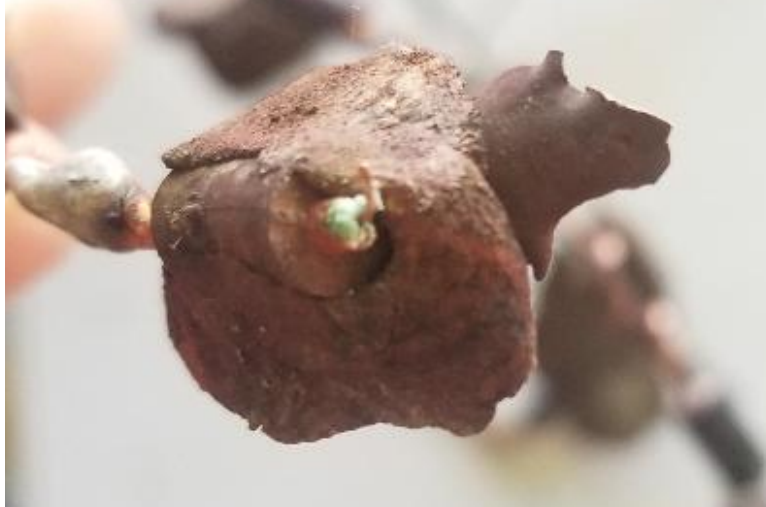
- Twisted connections between tin coated copper diode leads and copper lead wires, as well as diode lead to diode lead connections submersed in erythritol. These cookers usually stopped allowing current to flow within a few months of use. After being dissected, evidence of what is believed to be electrolysis was found. Figure 1 shows the notorious green color of corroded copper on the diode's lead wire. The corrosion progressed through the tin coating and nearly to the center of the lead wire. The confusing issue is that sometimes this green color is found on the most positive lead, and sometimes on the negative lead. Generally, we would expect the green color to be found on only one lead. Another cooker constructed in this way allowed current to flow for only 1 day. Then next morning it mysteriously did not work, after working perfectly the night before.

Figure 1. Corroded diode lead of a cooker constructed by twisting all connections. Surrounding the diode is erythritol and JB weld. During construction, diode bodies were glued to the pot using JB weld, but leads were left uncoated.

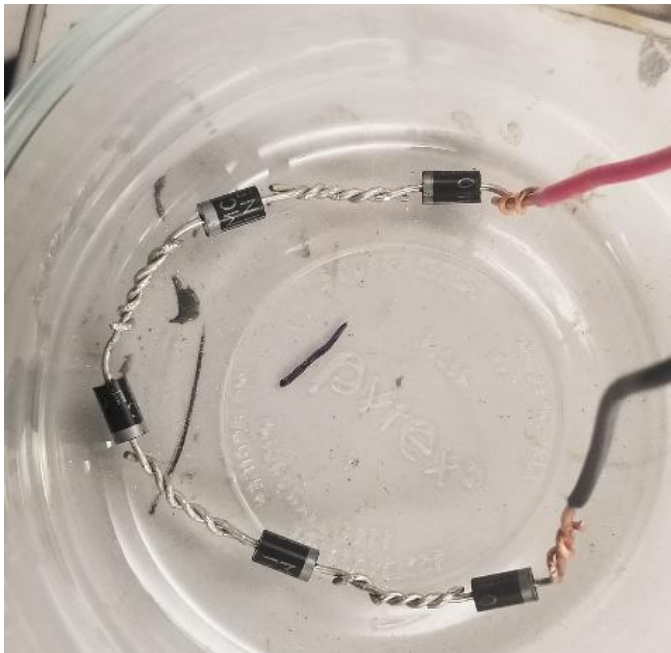
Erythritol Bath 1 (see Figure 2): Applied current of 6A. Diode chain composed of single stranded copper leads connection to sanded copper diode leads on each end, then 5 tin (nonsanded) diodes for the middle of the chain. **We suspected corrosion to occur here, but suspected it might not cause a loss of electrical connection.**

Figure 2: Bath 1 before adding erythritol.

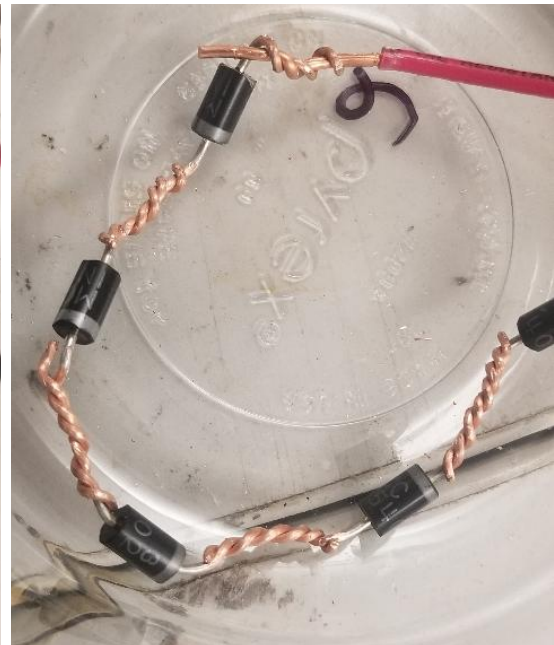
Erythritol Bath 2 (see Figure 3): Applied current of 6A. Single stranded copper leads, 5 diodes with sanded copper leads. **We suspected no corrosion to occur here.**

Figure 3. Bath 2 before adding erythritol

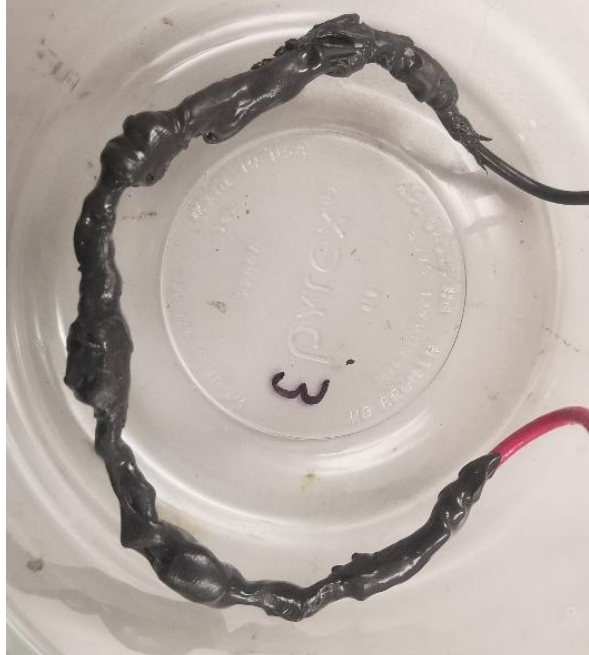
Erythritol Bath 3 (see Figure 4): Applied current of 6A. Single stranded copper leads, tin diode leads, with the whole chain coated in JBweld. **We suspected no corrosion to occur here.**

Figure 4. Bath 3 before adding erythritol.

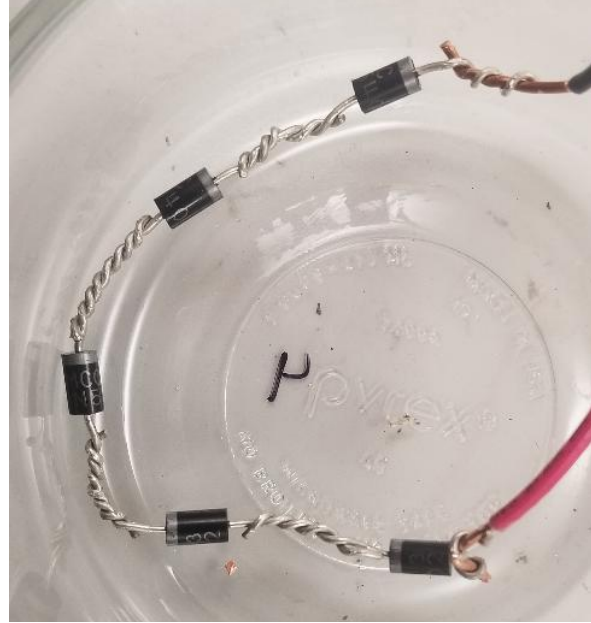
Erythritol Bath 4 (see Figure 5): Applied current of 6A. Single stranded copper leads, tin diode leads, no JBweld coating. **We suspected corrosion to occur quickly here.**

Figure 5. Bath 4 before adding erythritol.

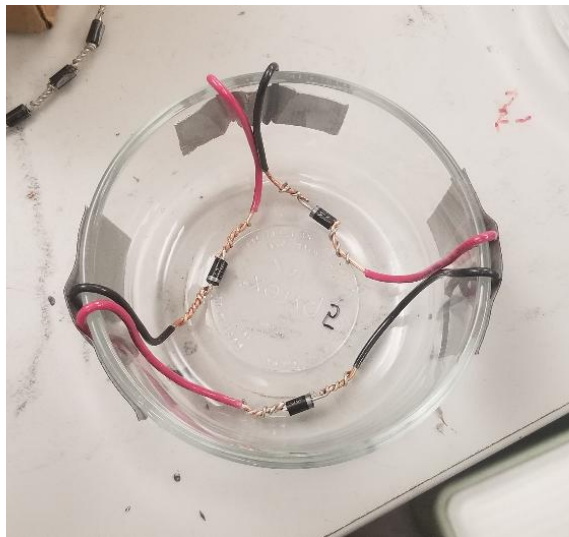
Erythritol Bath 5 (see Figure 6): There was no voltage or current applied. 3 items were placed in this bath: A single stranded copper wire and tin diode lead twisted directly together, a single stranded copper wire and sanded copper diode lead twisted directly together, a single stranded copper wire and tin diode lead twisted directly together and coated with JB weld. These three items never physically touched but were in the same bath of erythritol. **We suspected corrosion to occur on copper and tin twisted together without JBweld.**

Figure 6. Bath 5 before adding erythritol.

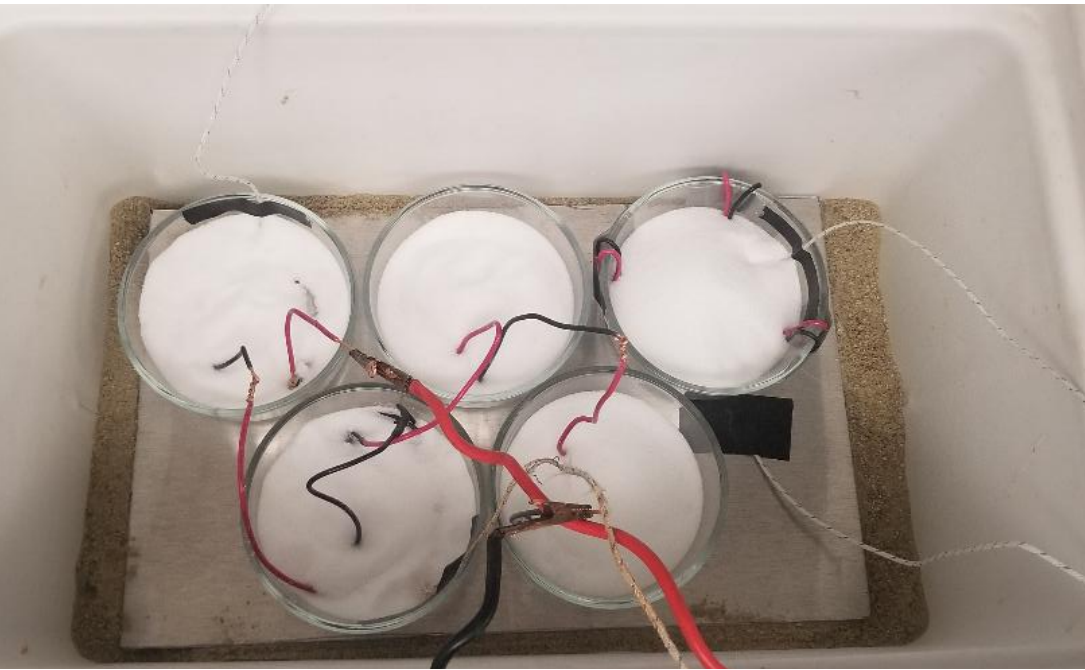
Figure 7. The cooler consisting of all baths filled with erythritol.

- After running the above experiment for about 2 hours, the circuit opened. As shown in Figure 7, the erythritol was in powder form. When it melts for the first time it will drop to the bottom of the bath and leave a cavity of un-melted erythritol around the diodes, insulating them. A few diodes were damaged, so I rebuilt all 4 chains and refilled each bath with 250g of erythritol before restarting the experiment. When I did restart it, I agitated the erythritol by hand, so it was always in contact with the diodes.

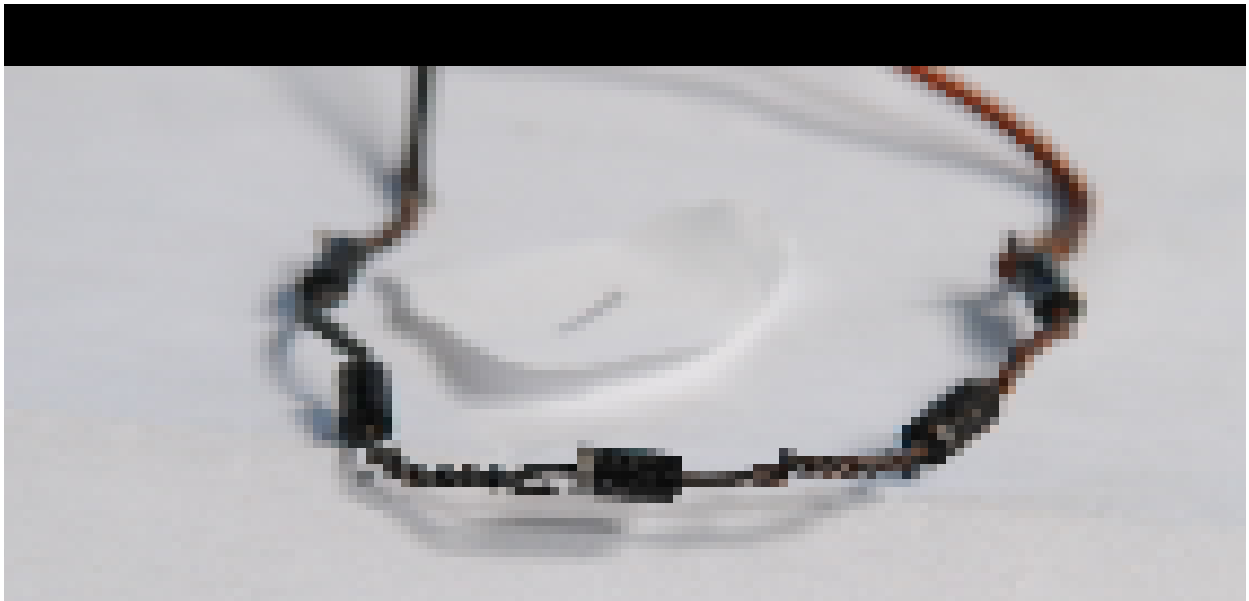
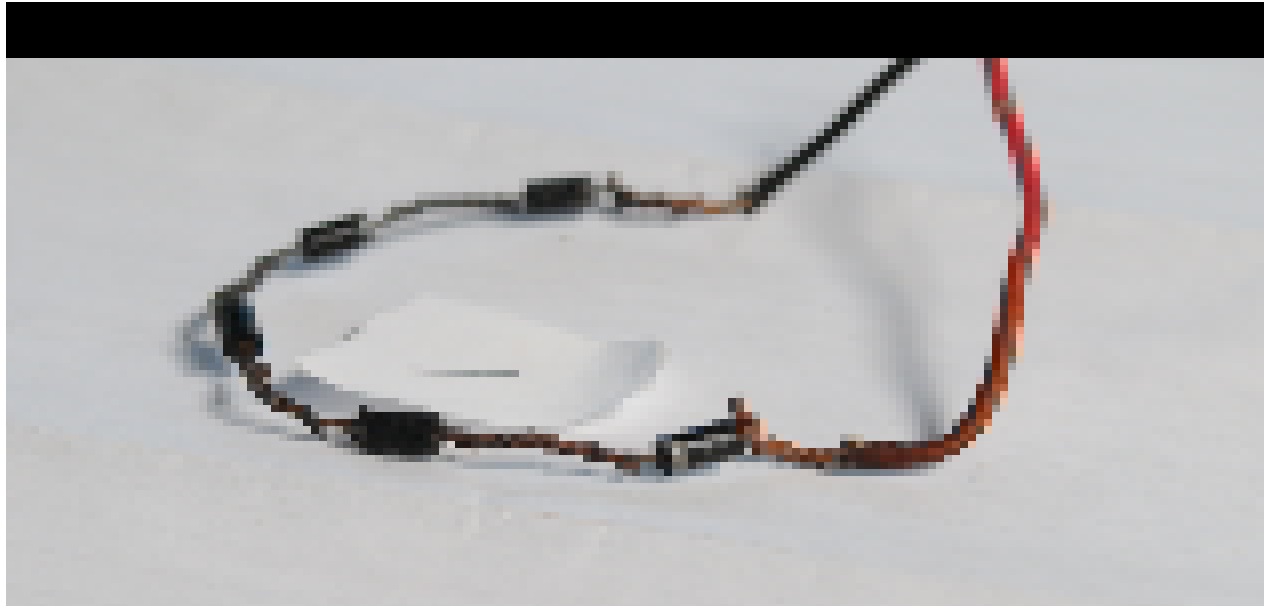
- Bath 1 (Figures 8-10): The chain with sanded copper leads on the most positive and negative connections only (not sanded, tin diode to diode connections) from bath 1 has a visible black coating which is thicker on the negative half of the chain (first 3 connections) than the positive half (last 3 connections). It allows current to pass, but as previously stated, needs to be held in a certain position from time to time, and has loose connections. It was also taken apart, cleaned with sandpaper, and put back together twice during the experiment. When preparing this chain, the tin was sanded by hand and there was still a small amount of tin near the diode body on the most positive and negative diode to lead connections (as well as tin covering each diode to diode connection). This small amount of tin near the diode body is still visible on the most negative diode to lead connection (Figure 8) but has corroded away on the most positive diode to lead connection (Figure 10). The tin is completely corroded away from the most positive diode to diode connection (Figure 10) and is completely intact on the most negative diode to diode connection (Figure 8). Both connections in between have some tin left but not all (Figure 9). This confirms our mental model of electrolysis as the anode (positive lead) has corroded away while the cathode (negative lead) has stayed intact.

Figure 8: Negative end of chain from bath 1. This chain had been sanded at only the most positive and negative connections between the diodes and lead wires.

Figure 9: Middle of chain from bath 1.

Figure 10: Positive end of chain from bath 1.

- From the beginning of week 5 until the end of the experiment bath 1 experienced connectivity interruptions because of a loose connection between diode leads. The black coating was prominent. If I moved the chain around, I could usually get it to allow current to pass through temporarily while I held it in place. Twice during the remainder of the experiment, I had to remove the chain from bath 1, scrape off the black coating, and tighten the connections.

- The results seem to point to the **JB weld coated chains** (baths 3 and 5) **as the best performer** and the **sanded copper diode leads only on each end of the chain** (bath 1) **as the worst performer**.

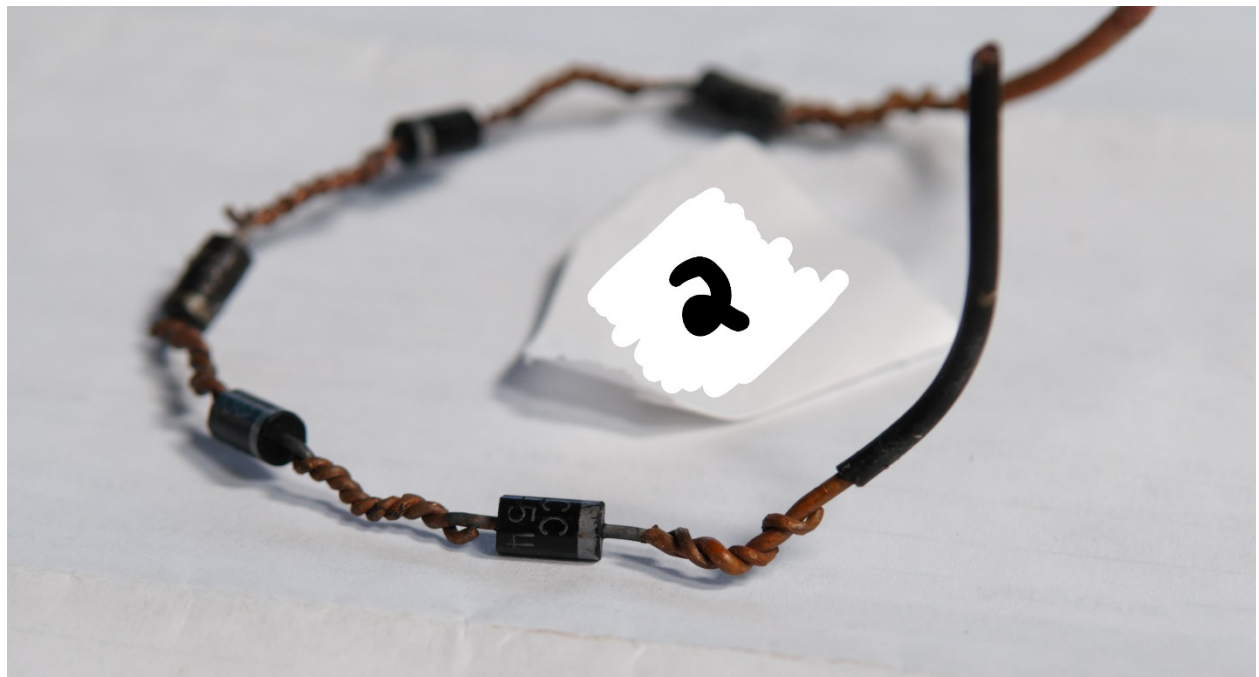
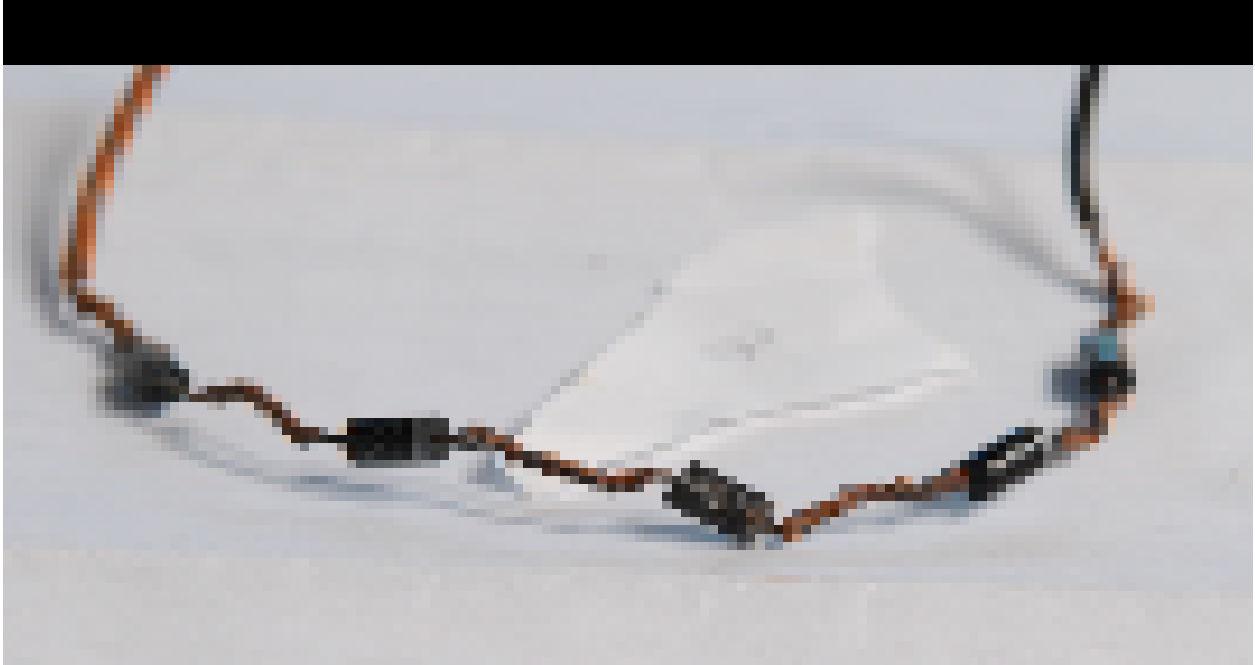
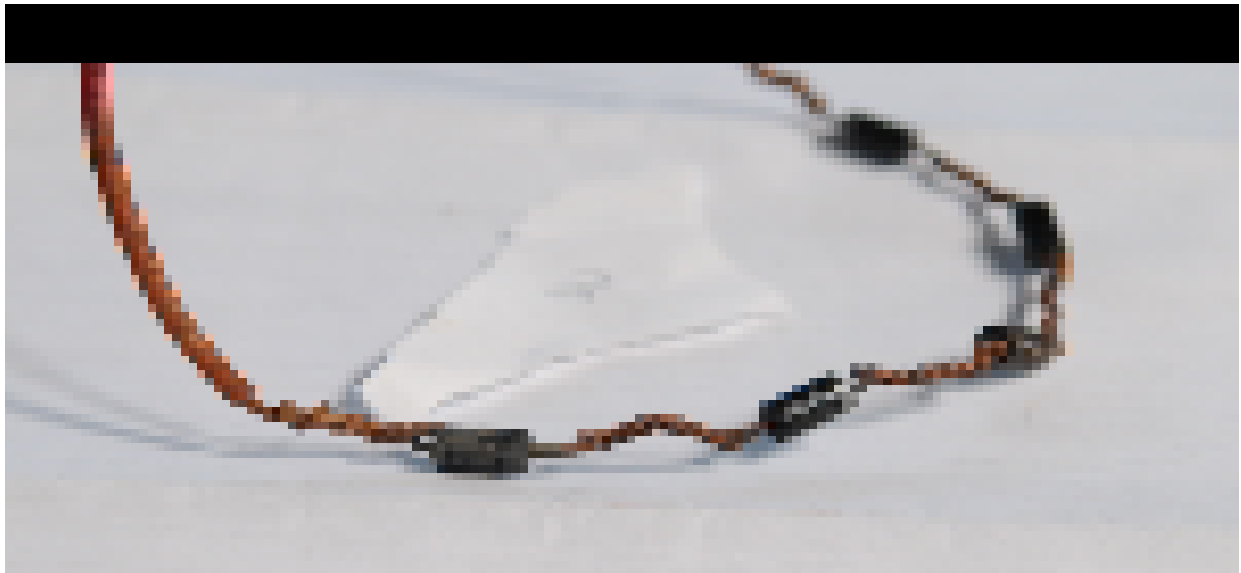
- Bath 2 (Figures 11-13): The chain with all leads sanded from bath 2 experienced a medium amount of corrosion. There is a black coating on portions of the leads between diodes. It is not a

heavy layer. This black coating is assumed to be tin deposition and is attributed to the tin that is left behind when sanding by hand is not done perfectly. The connections are not loose.

Figure 11. Negative end of chain from bath 2. This chain had all connections sanded to remove tin.

Figure 12: Middle of chain from bath 2.

Figure 13: Positive end of chain from bath 2.

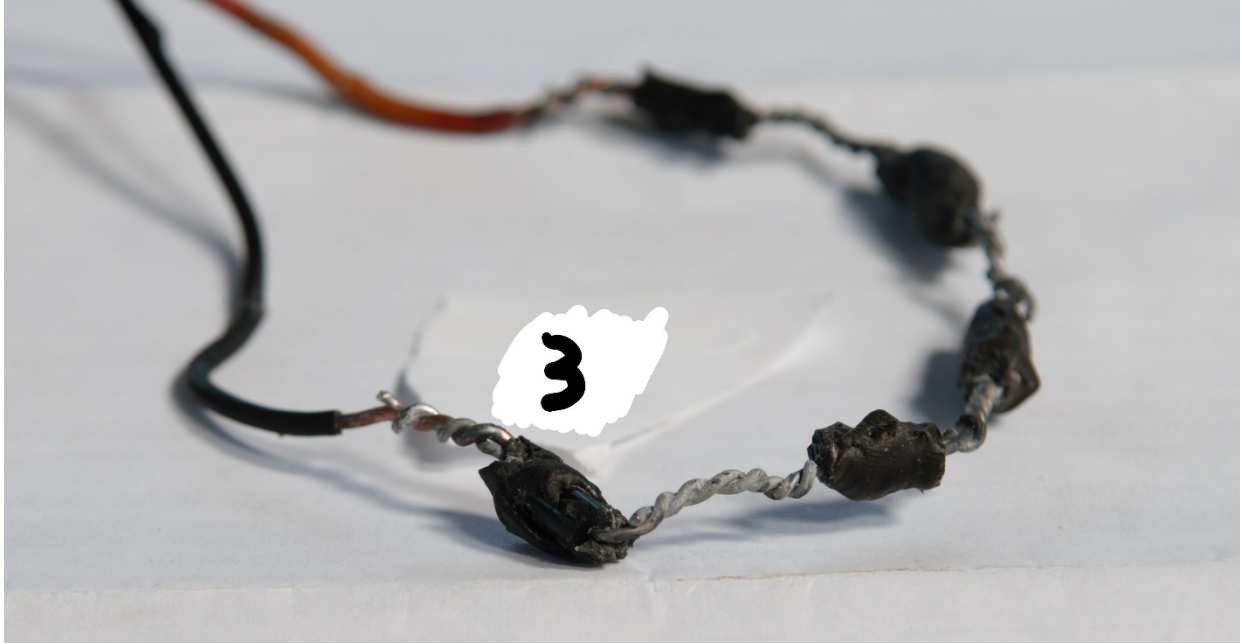
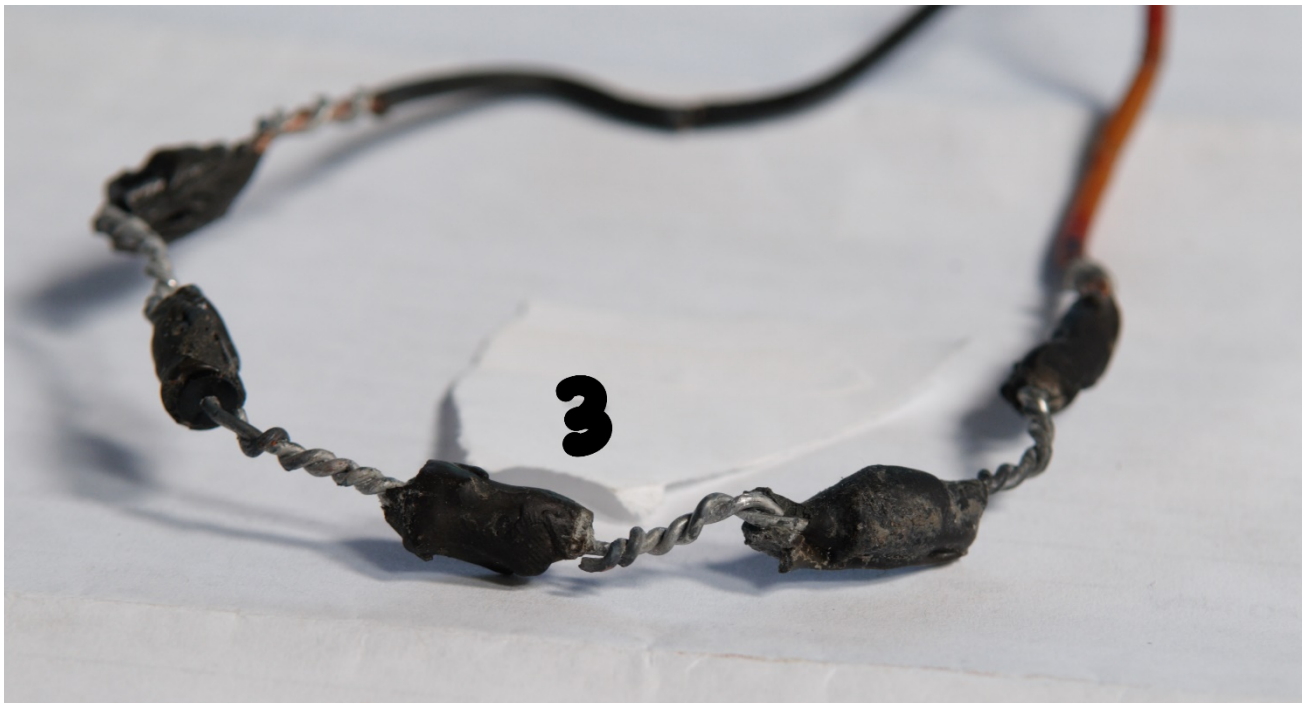
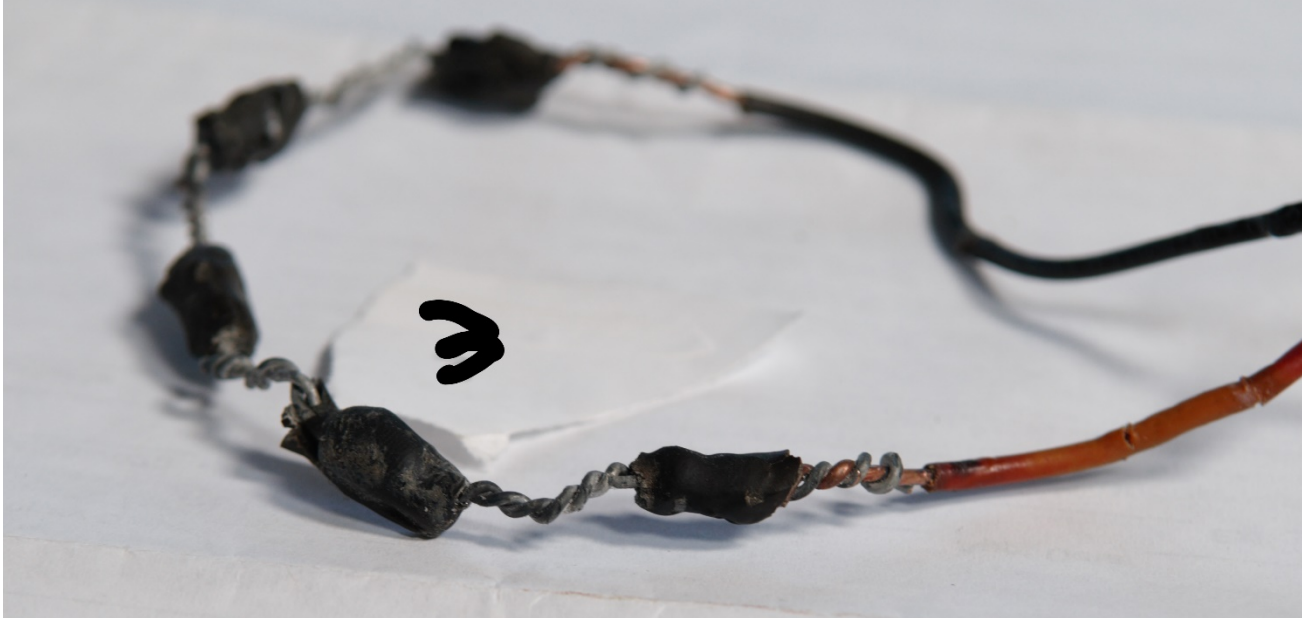
- Bath 3 (Figures 14-16): The JB weld coated chain from bath 3 experienced no visible corrosion and still allows current to pass through normally.
- Bath 4 (Figures 17-18) The chain from bath 4 with unmodified diode leads experienced little corrosion and looks much like it did before the experiment. There is a small amount of black coating on some of the diode leads, and it appears that some of the tin deposited on the most negative connection of that chain, where the diode lead connects to the copper lead. The positive copper lead wire is still copper colored while the negative copper lead wire is tin colored and will not come clean from a light sanding which usually cleans the black coating. The connections are not loose. NOTE: The broken diode in the middle of the chain did not break during the experiment. After the experiment was over, all baths were placed in an oven to melt the erythritol to remove the chains from their baths. Baths 4 and 5 were left in the oven the longest, potentially reaching 240 °C but not reaching a temperature high enough to have broken the diodes. The diode broke upon removing it from its bath with great force, because it had been taped to the bottom of the bath with gorilla tape.

Figure 14: Negative end of chain from bath 3. This chain was coated fully in JB weld and no connections were sanded.

Figure 15: Middle of chain from bath 3.

Figure 16: Positive end of chain from bath 3.

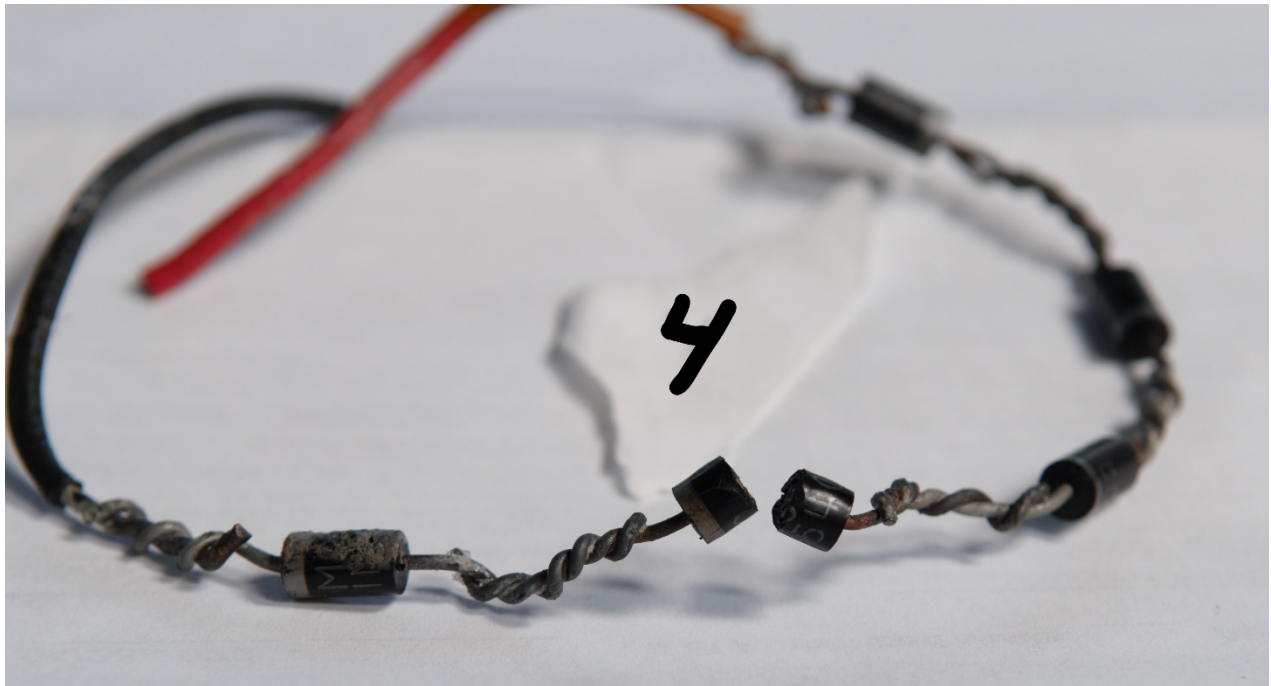
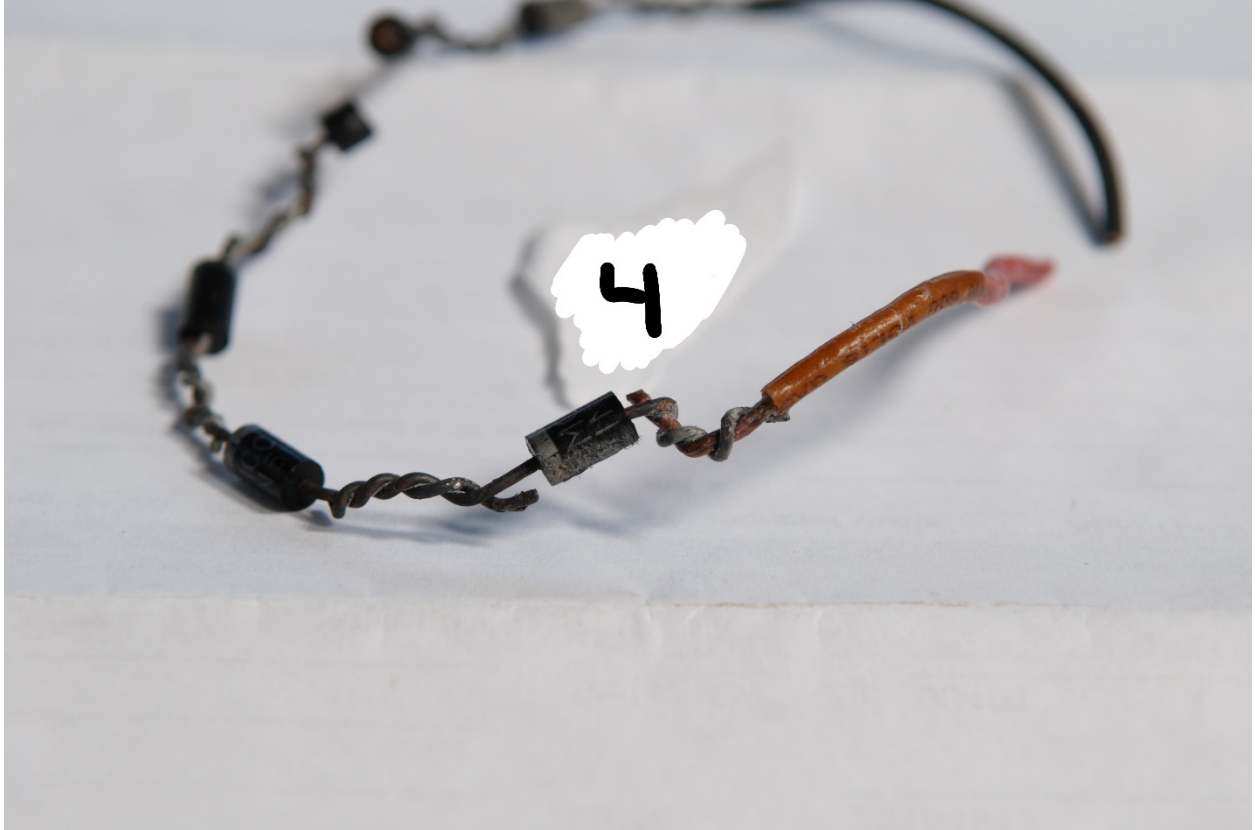
Figure 17: Negative end and middle of chain from bath 4. This chain was made with regular (not sanded) tin coated diode leads and copper lead wires.

Figure 18: Positive end of chain from bath 4.

- The corrosion of tin will cause connections to loosen over time. Tin essentially acts as a sacrifice, corroding before copper.
- Bath 4 would have likely corroded further and lost electrical connection if the experiment continued longer. It is unclear why bath 1 corroded faster than bath 4. Since corrosion in our cookers is now believed to be mainly due to electrolysis, and the speed of corrosion from electrolysis is determined by voltage (as well as conductivity of the solution) it is possible that a small difference in the forward bias voltage of the diodes could cause one bath to corrode faster than the others. In future experiments, the voltage across each diode chain should be monitored.

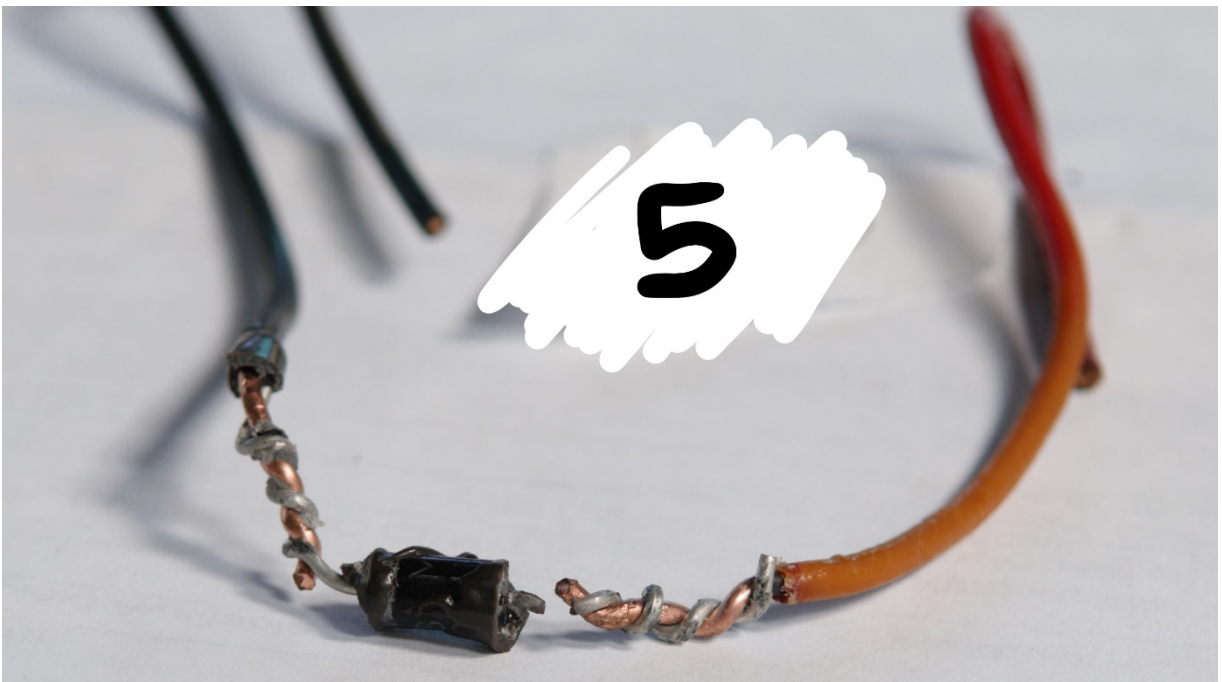
- Bath 5 (Figures 19-21) the sanded and un-sanded diode (Figures 20 and 21, respectively) both have the same very small amount of black coating on portions of the leads. The JB weld coated diode (Figure 19) experienced no corrosion and looks pristine. NOTE: The broken lead in Figure 19 did not break during the experiment. After the experiment was over, all baths were placed in an oven to melt the erythritol to remove the chains from their baths. Baths 4 and 5 were left in the oven the longest, potentially reaching 240 °C but not reaching a temperature high enough to have broken the wires. The lead broke upon removing it from its bath with great force, because it had been taped to the side of the bath with gorilla tape.

Figure 19: JB weld coated diode from bath 5. Diode lead was broken **after** the experiment.

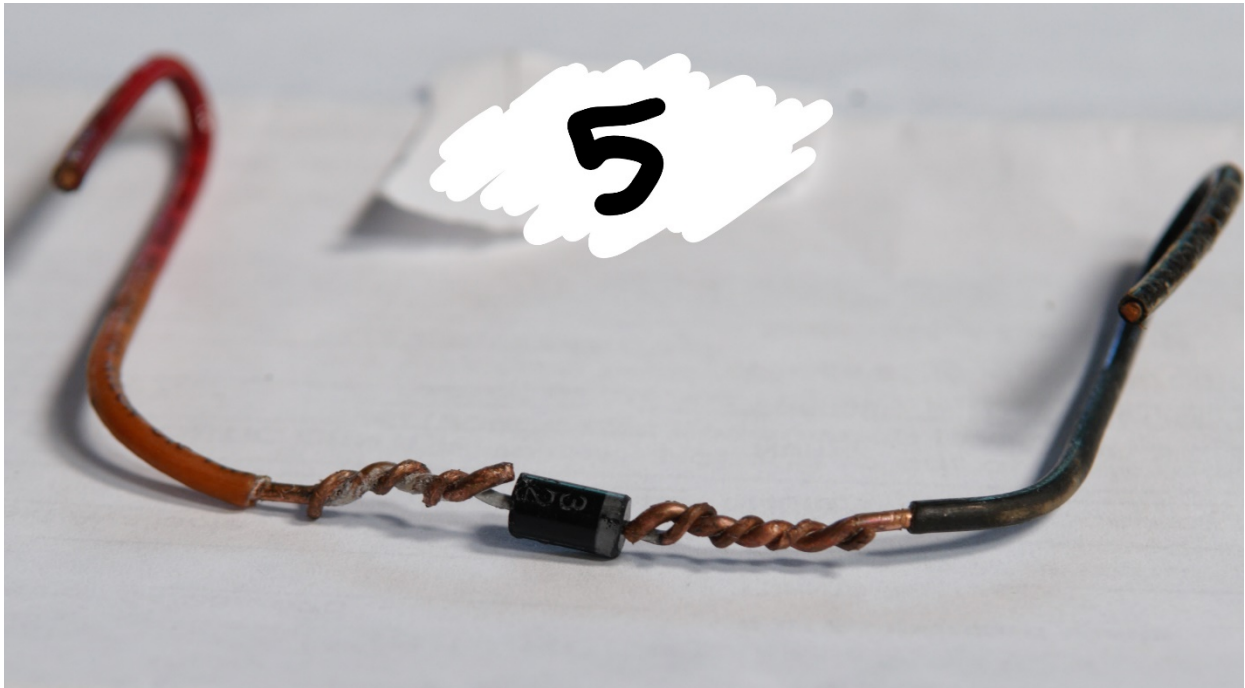
Figure 20: Diode with sanded leads from bath 5.

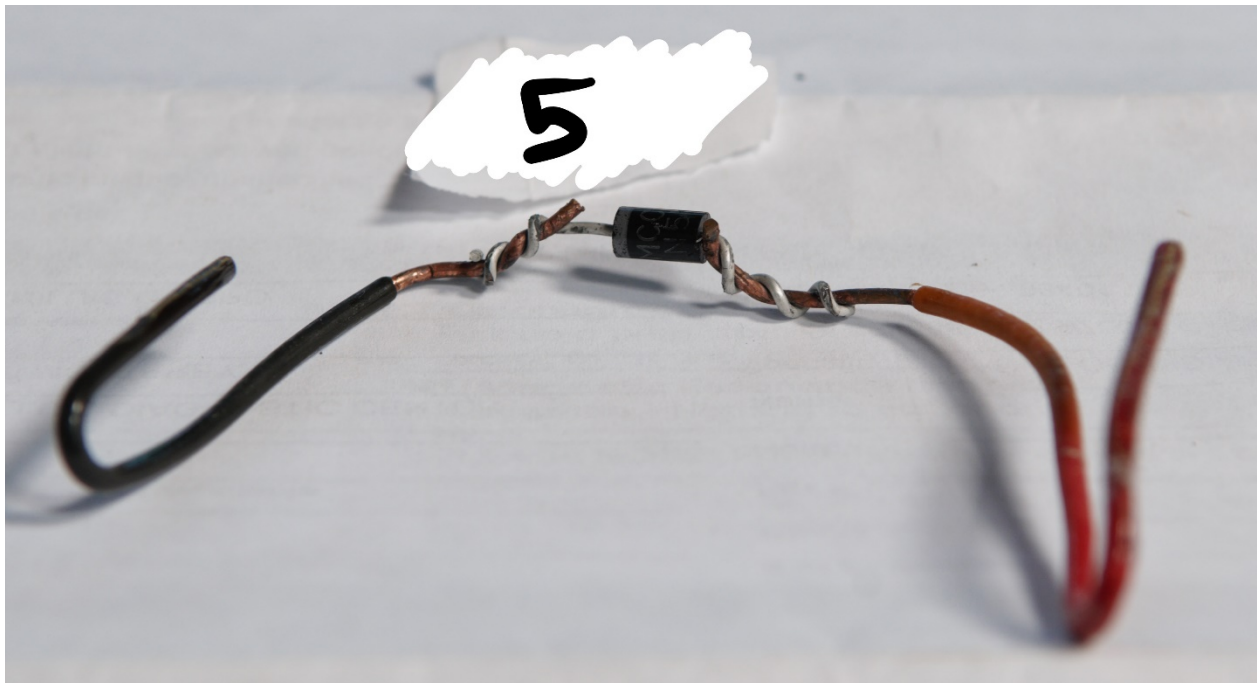
Figure 21: Diode with leads left not sanded (tin coated) from bath 5.
